**Docket No. 217 – Development and Management Plan Inspection**

Northeast Utilities Service Company Certificate of Environmental Compatibility and Public Need for the construction of a 345-kV electric transmission line and reconstruction of an existing 115-kV electric transmission line between Connecticut Light and Power Company's Plumtree Substation in Bethel, through the towns of Redding, Weston, and Wilton, and to the Norwalk Substation in Norwalk, Connecticut.

**Date:** December 8, 2005

**Location:** 345kV XLPE Component

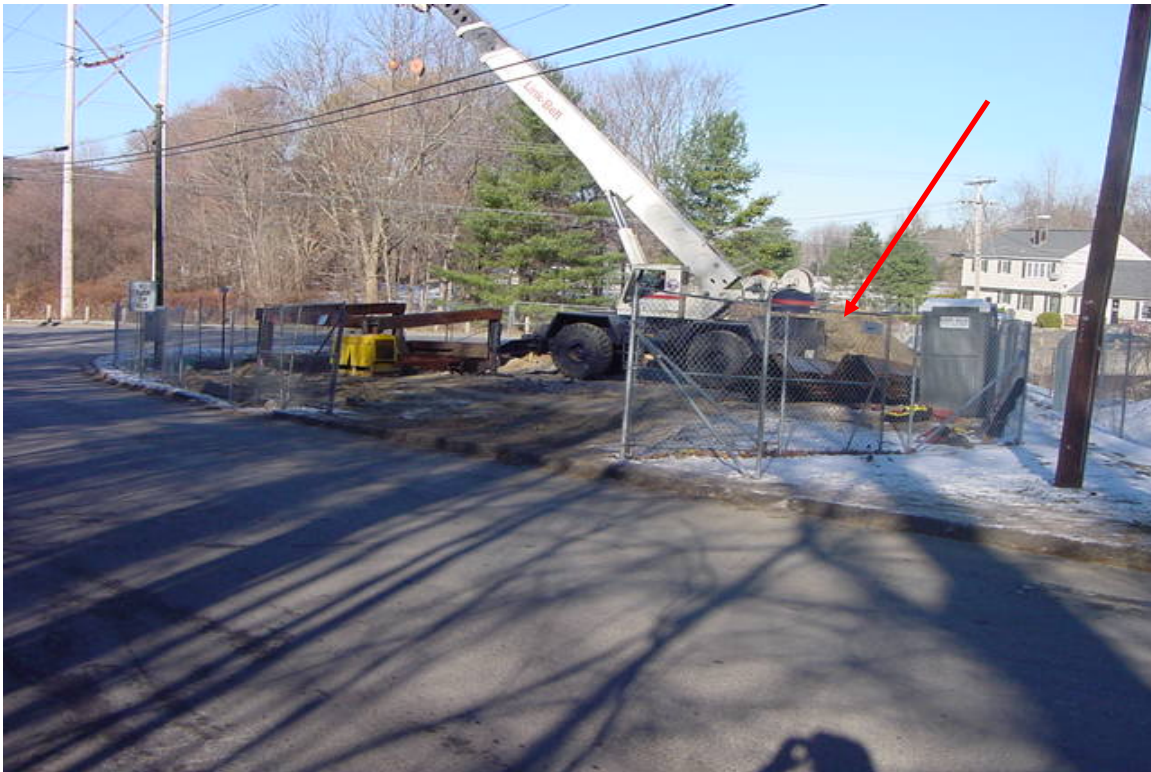
345kV XLPE (Jack and Bore): Overall view of the site with excavation underway and a stockpile in place (noted in the background of the photo). The stockpile is placed immediately adjacent to the silt fence and should be monitored carefully or relocation considered. 12/8/05

Areas of Inspection	Observation	Recommended Action
Access Roads and Adjacent Roadways	<p>-The only component of this project currently active is the preparation for a jack and bore of East Swamp Brook located at the intersection of Plumtrees Rd. Walnut Hill Rd. and Whittlesey Dr. 11/23-12/8/05.</p> <p>- A pad has been constructed off Whittlesey and Plumtrees Rd. for the bore pit. 11/23-12/8/05</p>	<p>-A stockpile is now in place in the vicinity of the road. An adjacent catch basin was noted and contractors were reminded to place controls here. 12/8/05.</p>
Trench and foundation construction	<p>-The bore pit pad has been partially placed with stone for equipment access. 12/8/05.</p> <p>- Excavation for the bore pit is underway and sheet piling/shoring is being constructed. 12/8/05</p>	<p>- The pad is fairly well contained at this time. 12/8/05.</p> <p>- None at this time. 12/8/05</p>
Erosion and Sediment Controls (includes inspection within 24 hours of a storm event)	<p>- Silt fence has been installed down gradient from the pad, but it needs to be toed in. 12/8/05</p> <p>-A stockpile is now on site due to the excavation. The pile was placed immediately adjacent to the silt fence. 12/8/05</p>	<p>- Check the fence and toe in where necessary. 12/8/05</p> <p>- Monitor closely due to proximity to silt fence or consider relocation of the pile. 12/8/05</p>

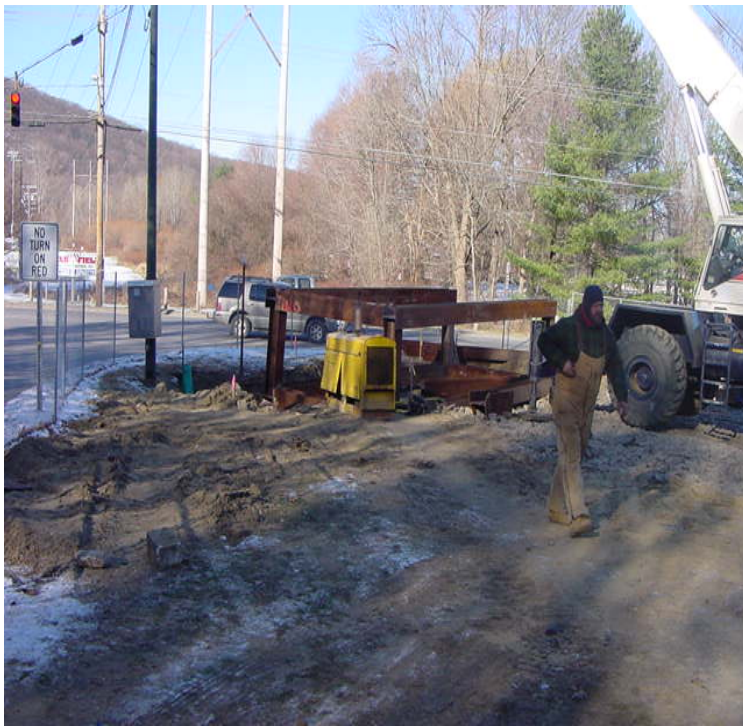
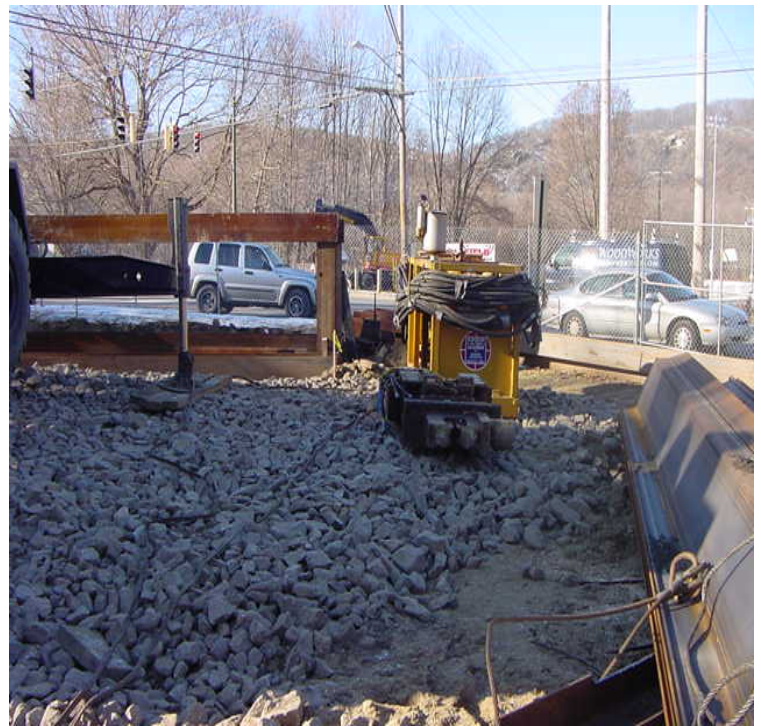
Views of the beginning of the excavation where sheet piling/shoring is being constructed for the bore pit. Stone has been placed on a portion of the yard. 12/8/05
